**Incident, Action, Recovery, and Recommissioning for
the 4.5-MJ Pulsed Power Supply Located at the
Electromagnetic Gun Facility, Barricade C,
Aberdeen Proving Ground, MD**

ARL-TR-4088

April 2007

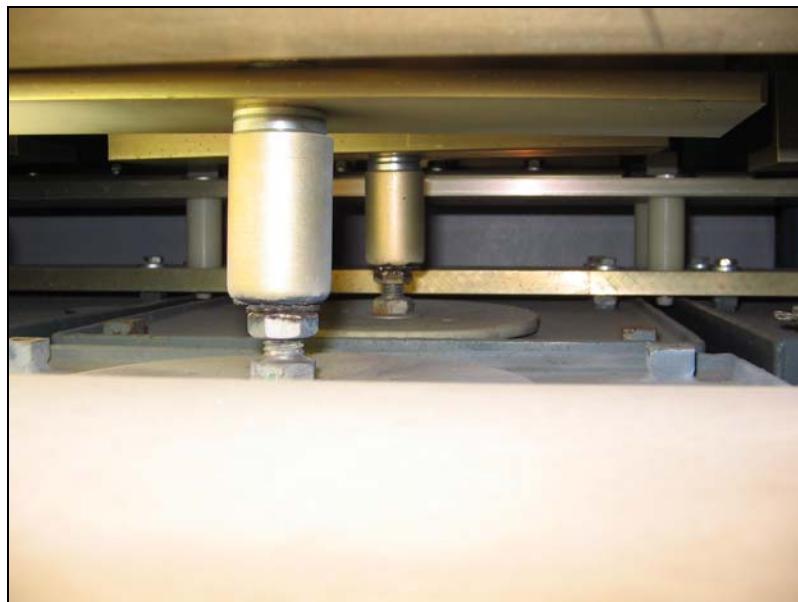
While inspecting the remaining modules and subsequent grounding, it was observed that several of the capacitors had discernable arc marks at the center post connection on the capacitor (see figure 12). The center posts on those capacitors were not making a secure connection.

Figure 12. Arc damage at the center post terminals of capacitors.

Figure 13 shows an illustration of the affected capacitors. It is clear that the damaged capacitor in module 4 was a result of the incident. Recent tests have shown that the arc damage at the center post terminal (see figure 12) was most likely a preexisting condition. The current generated by the fault was not sufficient to open the fuses protecting the other capacitors. As expected, the current from capacitors charged in module 4 that were discharged into the single faulty capacitor opened the fuses.

The refurbishment of the PPS required not only new capacitors but also new center post terminals. After assessing the failed center post, a new connector was designed that should be less prone to failure. This new connector design included a second nut to ensure a more robust connection in the presence of electromagnetic forces and the vibrations due to nearby conventional gun firings. Perhaps more importantly, the new connector was fabricated from brass rather than a chromated aluminum. This change in material should reduce the electrical losses between the steel center post stud and its terminal, thereby minimizing the potential for arcing. A picture of the new connection to the center terminal of the capacitor is shown in figure 15.

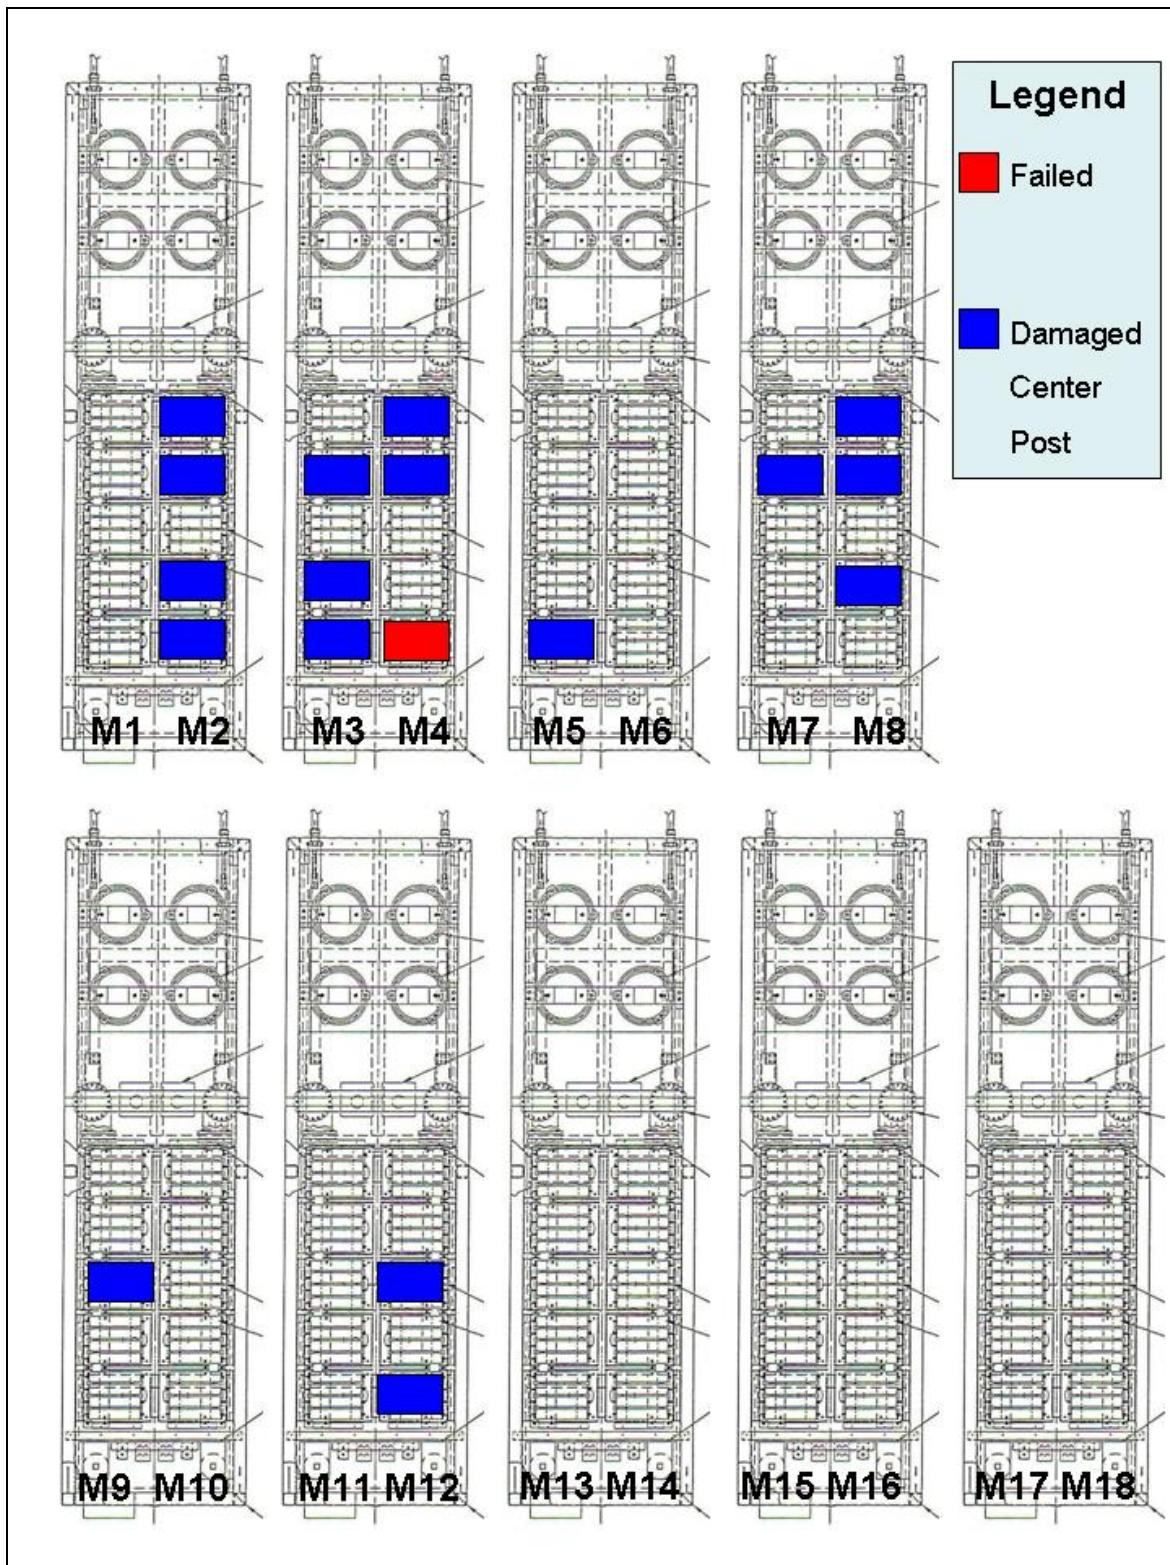
Currents from modules 5 and 6 were discharged into the gun and armature, as evidenced by the peak detectors and a small displacement of the projectile loaded in the railgun. Pretriggering of the ST-300 has been observed under a variety of situations. The electronics in the trigger generators, resident on each module and adjacent to the capacitors, are susceptible to noise, especially during fault conditions. Modules 5 and 6 discharged after the HVCPS had disconnected from the charging circuit.

Figure 13. Schematic illustration of affected capacitors.

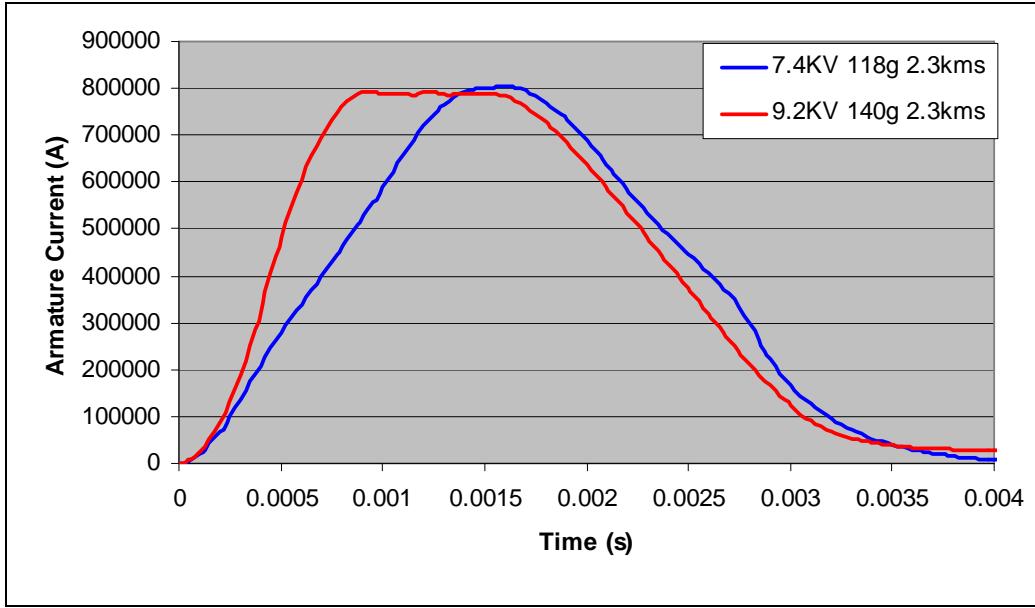
Consider the challenge, with regard to pulse shape, that using the original Aerovox capacitors presents. The shape of the current pulse has been found to determine the time when a solid-armature contact transitions from metallic operation to a plasma interface (7). A less than ideal pulse shape was selected, based on charge voltage considerations, for the majority of the FY06 tasks. That pulse is shown in figure 14 for a charge voltage of 7.4 kV. The rise time is rather slow, and the duration of the flat portion of the pulse is only a small fraction of the in-bore residence time. Now consider the alternate pulse shown in figure 14, which is better for solid-armature operation and delivers 20% more kinetic energy. This modified pulse, however, relies on achieving a charge voltage of 9.2 kV.

Figure 14. Comparison of pulse shapes for 7.4 and 9.2 kV.

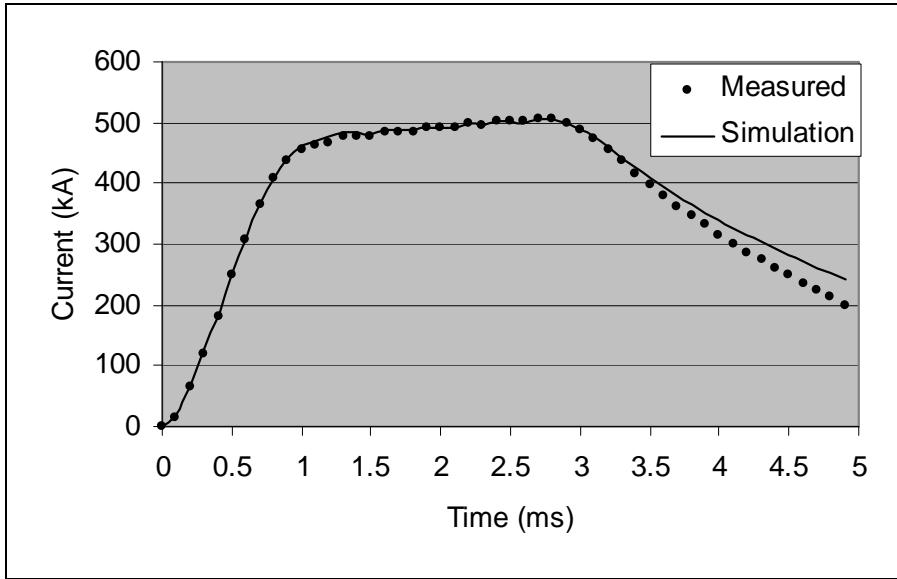
Figure 18. Comparison between data and simulation for sequential discharge test (18 modules).

All modules were operated together by sequentially discharging them into the short. For this test, the peak current in the short must be limited to about 500 kA. A typical pulse shape for operating a railgun can be attained using all the modules at a charge voltage of 5 kV. A comparison of the data and simulation is shown in figure 18. As can be seen, relatively good agreement is obtained through the duration of the discharge.

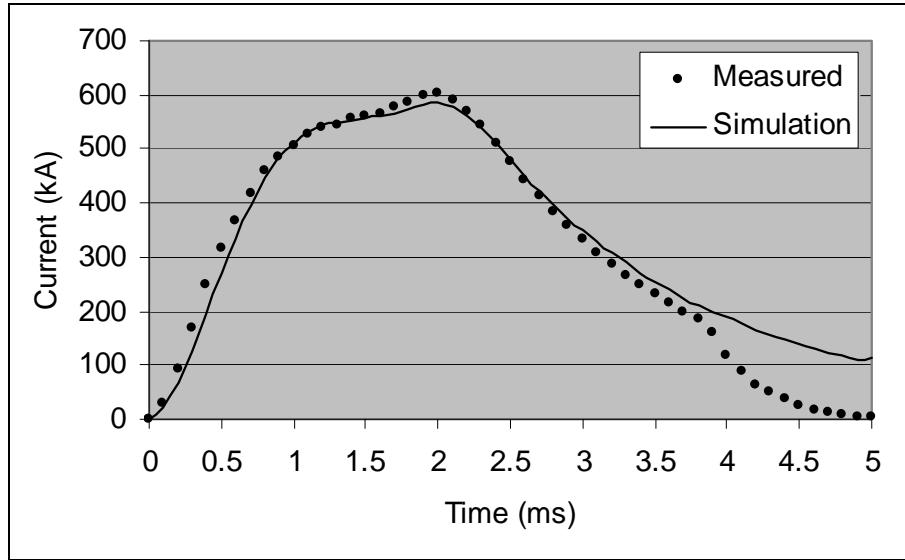
Figure 20. Comparison between measured and simulated currents at 6 kV (mCTL shot 370).

The commissioning tests started at an initial charge voltage of 5 kV. The charge voltage increased as confidence in operations was gained. A comparison of the measured and simulated currents for the 6-kV shot is shown in figure 20. As can be seen, there is relatively good agreement. The majority of the discrepancy occurs during the falling portion of the current when the armature has first transitioned ($t = 2.2$ ms), albeit momentarily (~ 50 μ s in duration). Thereafter, the contact recovers to a metallic sliding contact with intermittent arcing. The armature contact fully transitions to a plasma interface when the voltage exceeds 70 V at 3.1 ms.

Predicting transition in railguns has proven to be elusive. Fortunately, very little projectile acceleration occurs after this event and, therefore, represents very little perturbation to predicting current and exit velocity.

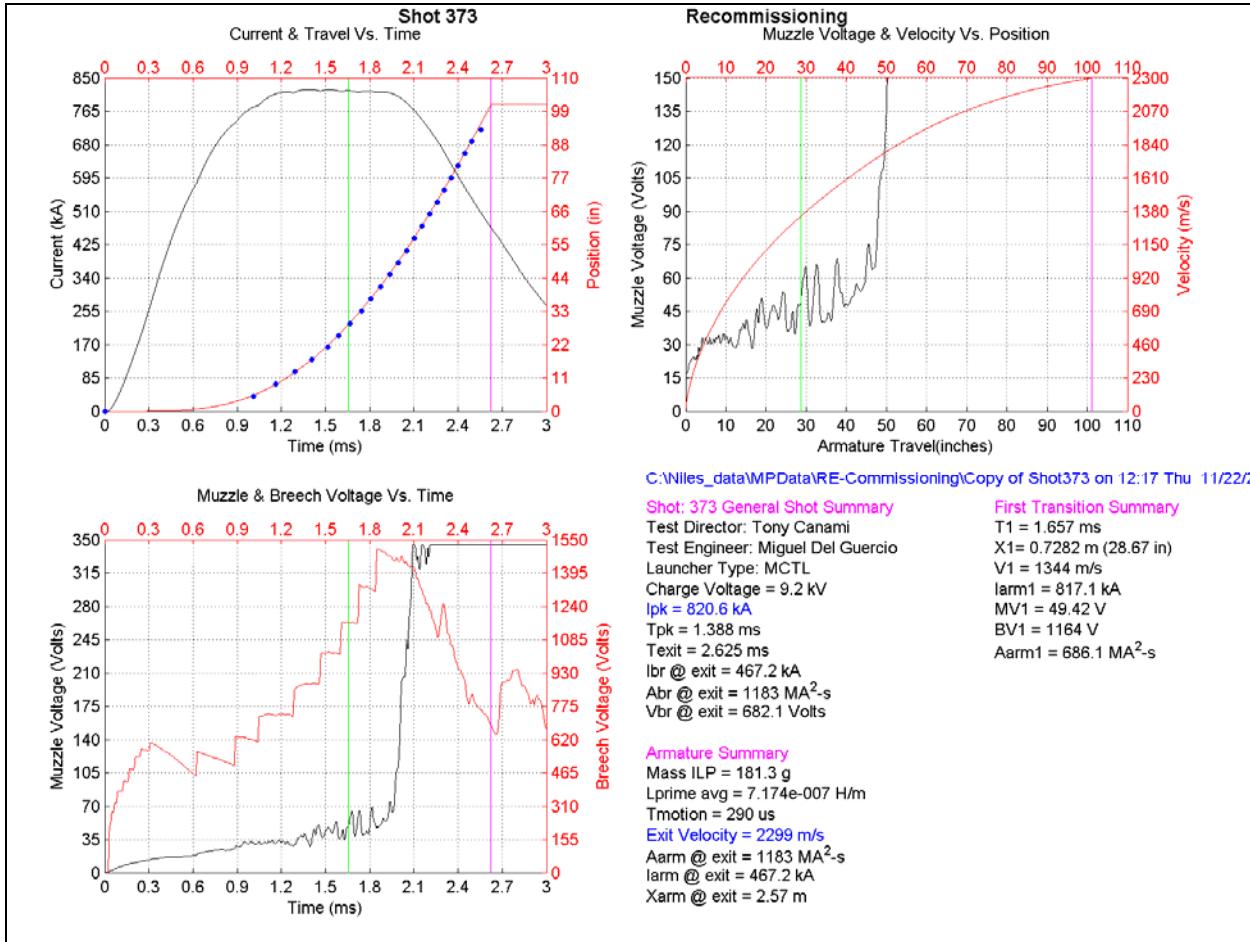
Figure 21. Data summary page from commissioning shot at 9.2 kV (mCTL 373).

The final shot of the commissioning tests was executed at a charge voltage of 9.2 kV. The summary page from the data acquisition system is shown in figure 21. All data were successfully captured and analyzed without incident.
